Inspection Date Report No Client August 19, 2023 85317536

XXX 8th St

Jersey City, NJ 07302

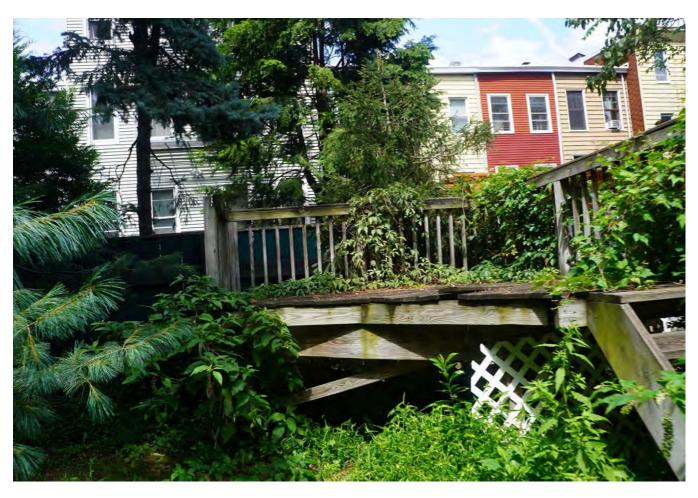
Wear & deterioration noted at deck. Regular service / maintenance is needed to prolong longevity. Heavy wear noted at detached rear deck structure - recommend removal.

Wear at rear deck

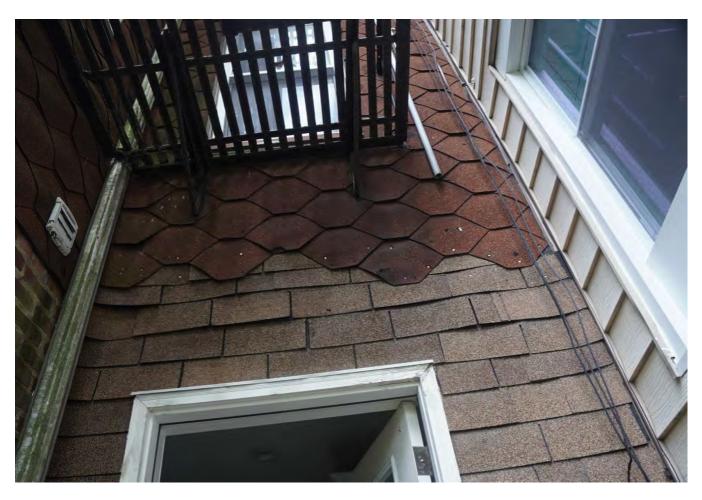
Wear / aging noted at exterior walls. Regular service / maintenance is needed to prolong longevity. Rear siding at end of serviceable lifespan with heavy wear / aging - further evaluation for replacement is needed to prevent moisture penetration / damage.

Heavy wear at rear facade

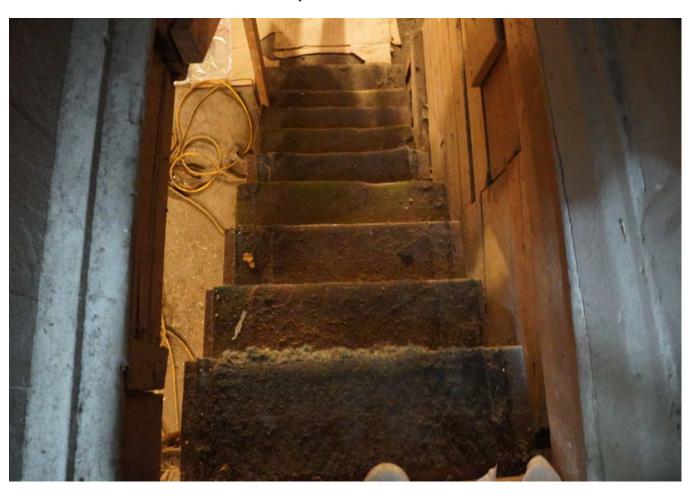
Basement stairway

Wear / aging noted at basement stairway. Railing missing at basement stairway - installation is needed for safety.

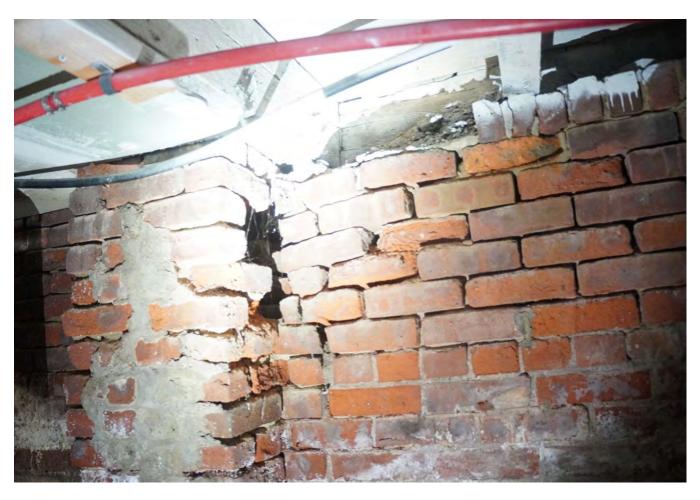
Gap noted at basement exterior walkout door - repair is needed. Moisture noted at basement interior. Microbial growth noted at basement interior - remediation is needed. Recommend installation of dehumidifier to reduce moisture levels. Further evaluation for waterproofing is needed. Construction debris noted in basement - removal is needed. Loose & worn bricks & deteriorated mortar noted at interior foundation walls - further evaluation & repair is needed by a masonry contractor to maintain structural integrity of the building.

Heavy wear & deterioration at foundation wall

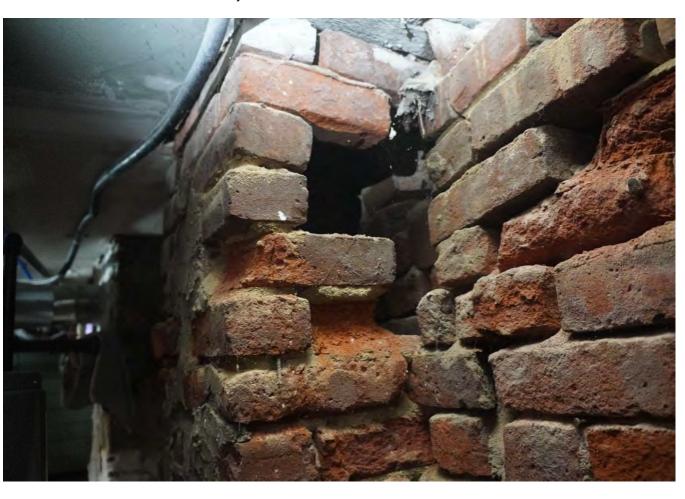
Heavy wear & deterioration at foundation wall

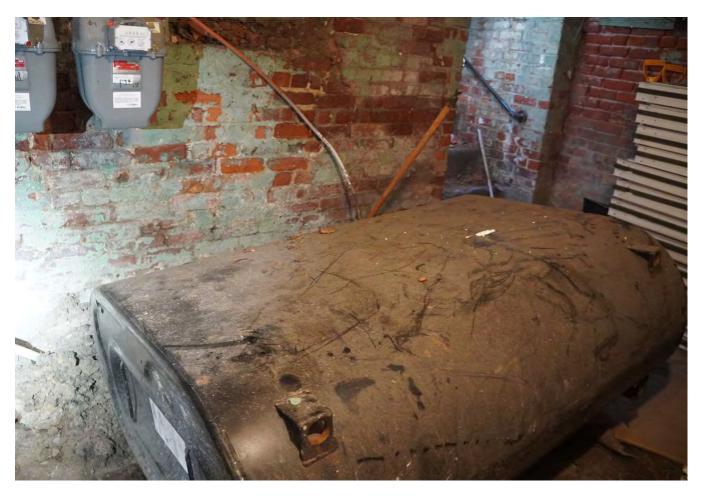
Abandoned oil tank present at basement - recommend removal. Evidence of previous oil lines observed at basement, inquire with seller regarding previous oil tank placement & proper removal - recommend soil testing for contamination if applicable.

Oil tank

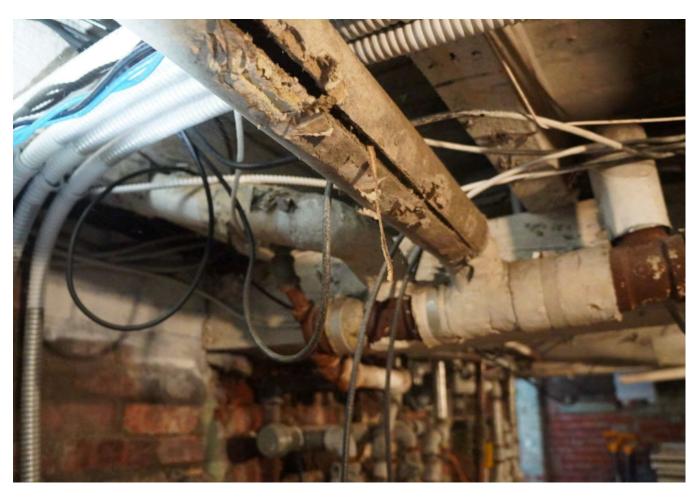
Suspected asbestos containing materials noted at heating pipes at basement, abatement by a remediation specialist is needed for health safety.

Suspected asbestos containing materials at heating pipes

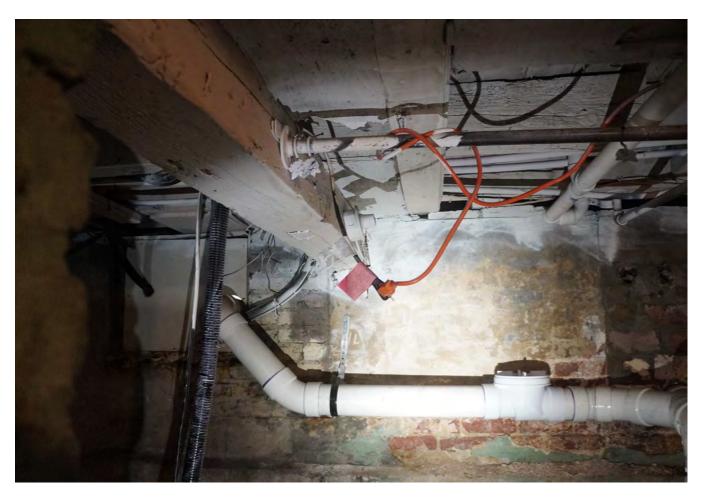
Twisting noted at main girder and joist - further evaluation for reinforcement is needed by a structural contractor to maintain structural integrity of the building.

Twisting at main girder

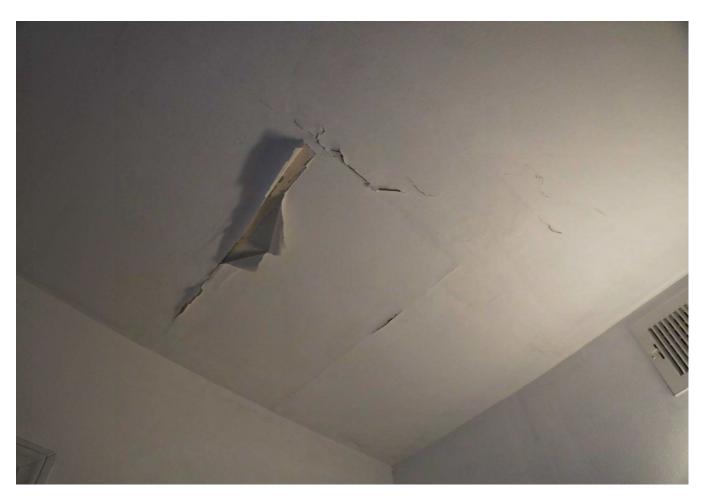
Ceiling moisture stains noted throughout top floor unit (see Roof). Active moisture readings noted at unit 2 bathrooms - further evaluation / repair is needed. Microbial growth noted at unit 4 HVAC closet ceiling - further evaluation / remediation is needed.

Ceilng moisture damage

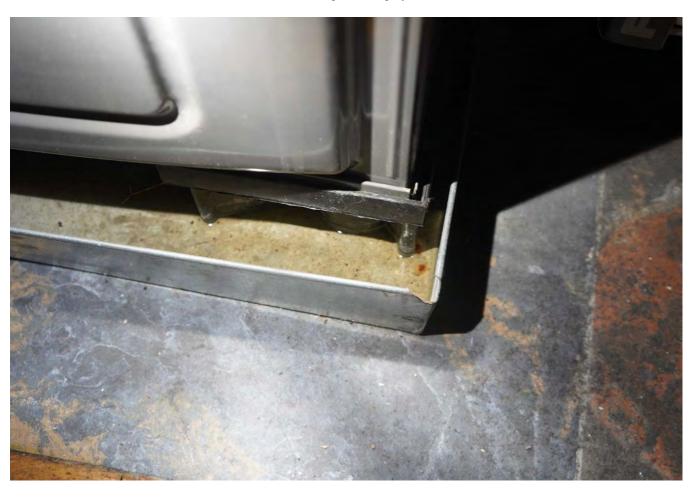
Poor location of return and thermostat noted at all heating / cooling systems, relocation is needed to maintain better climate control. Moisture noted at unit 2 catch pan - further evaluation / repair is needed by an HVAC contractor.

Moisture at catch pan

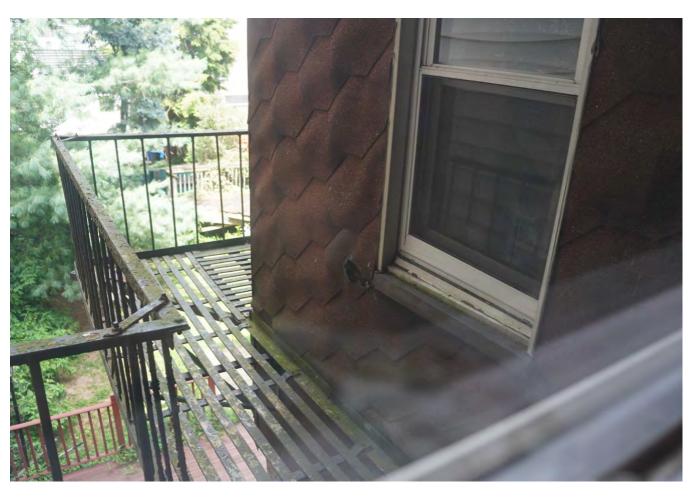
Damaged siding

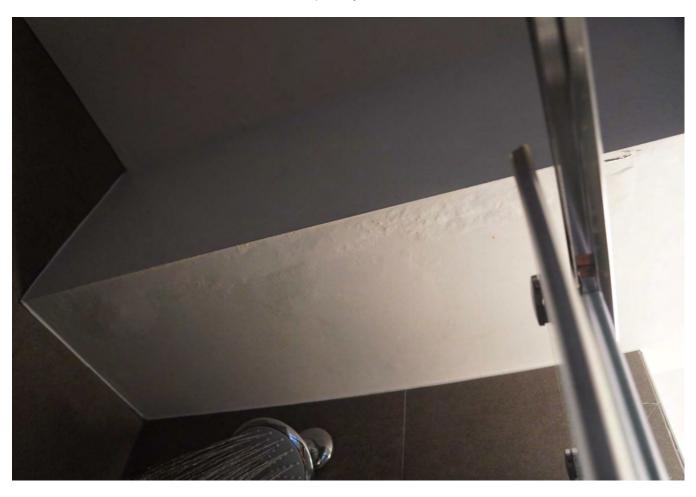
Ceiling moisture damage

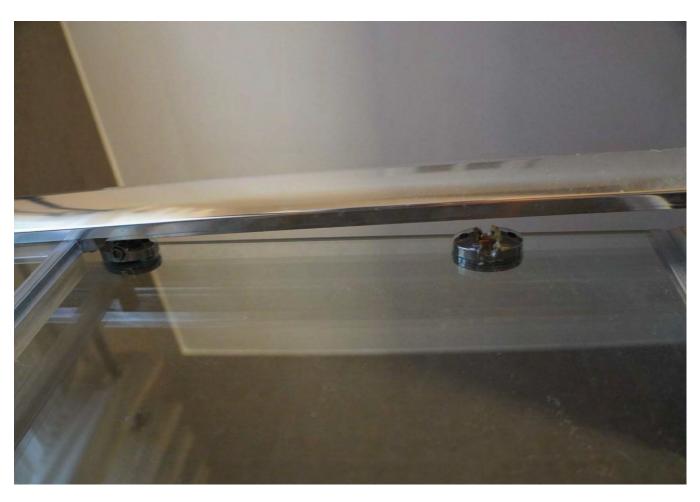
Shower handle damaged at unit 4 main bathroom - repair is needed. Shower mixing valve not operating properly at unit 1 bathroom 2 - repair is needed. Shower door track damaged at unit 3 primary bathroom - repair is needed.

Shower door damaged

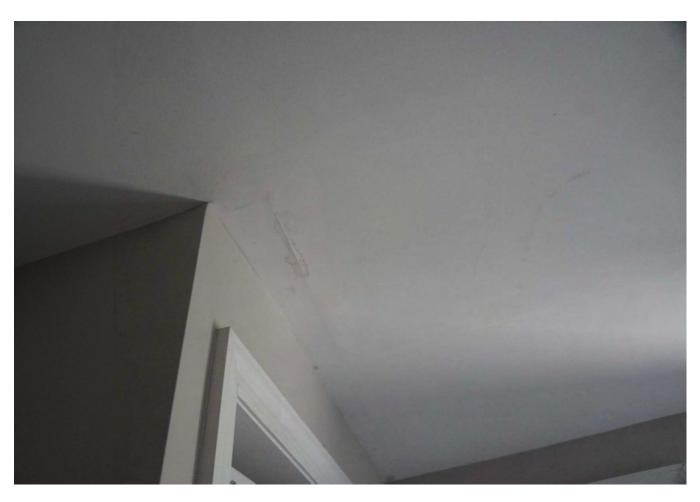
Ceiling moisture stain

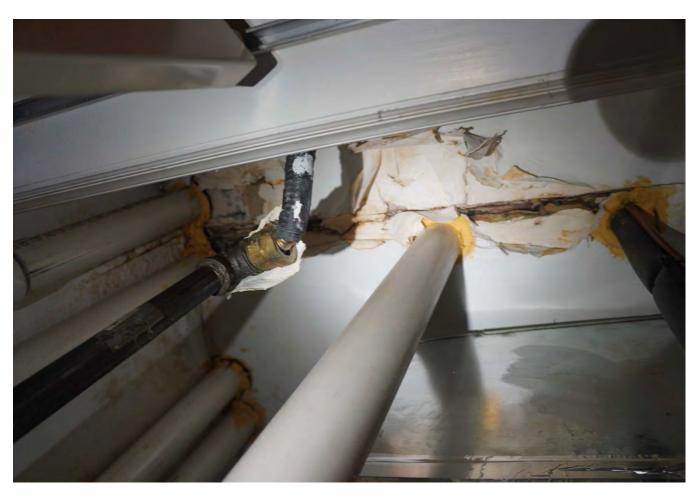
Ceiling moisture damage

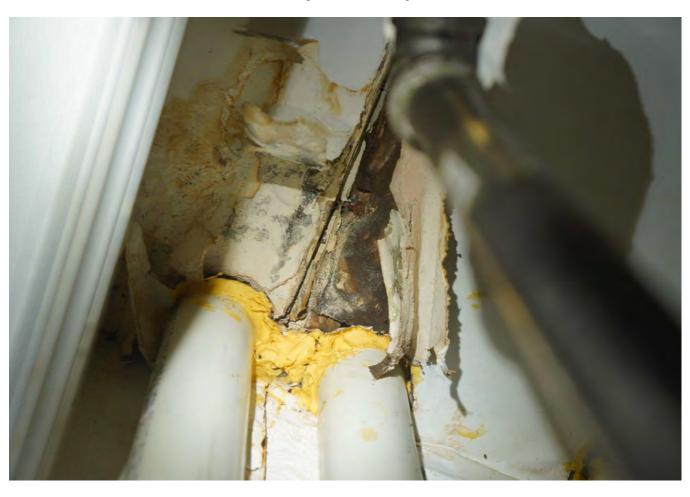
Microbial growth at ceiling

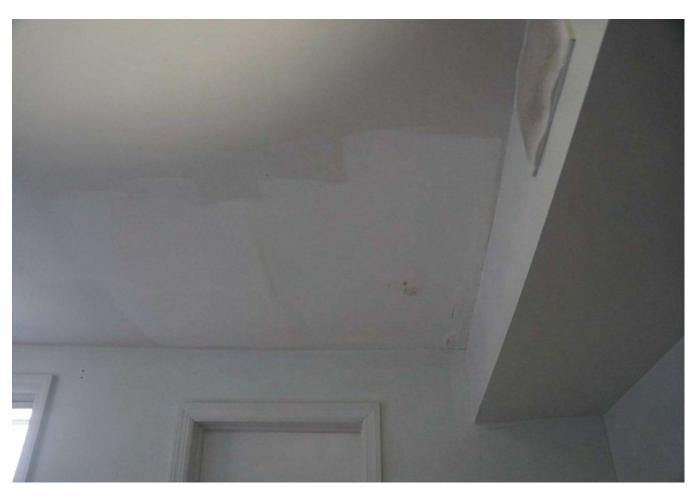
Ceiling moisture stain

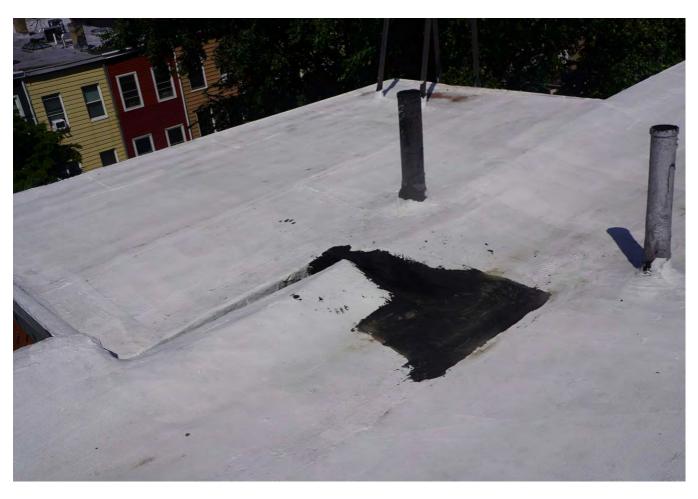
Moisture stains & damage noted at ceilings throughout top floor unit. Evidence of prior patching and repairs noted at roof - request further information from seller. Roof covering showed signs of blistering & open seams. Further evaluation for repair is needed by a roofing contractor. Recommend removal of satellite dish to prevent further wear to roof. Regular maintenance is recommended to the low slope roof. This usually consist of covering all exposed areas with additional aggregate material, repairing any open seams, repairing all / any cracks in the flashing and roofing material.

Repair at roof

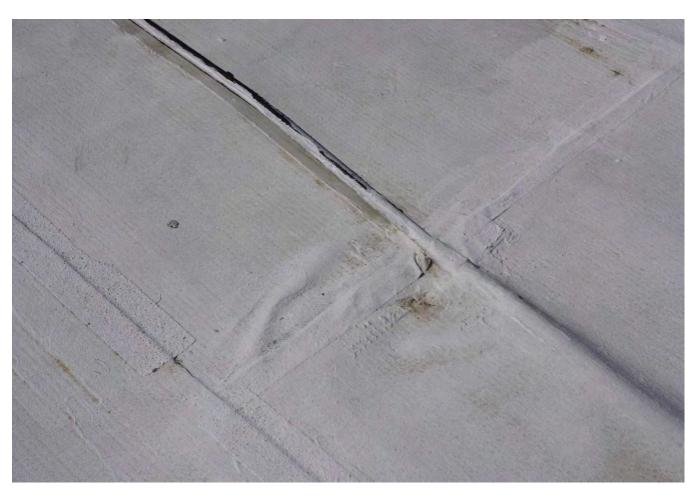
Blistering at roof
