Inspection Date Report No Client August 19, 2023 85317536

XXX 8th St

Jersey City, NJ 07302

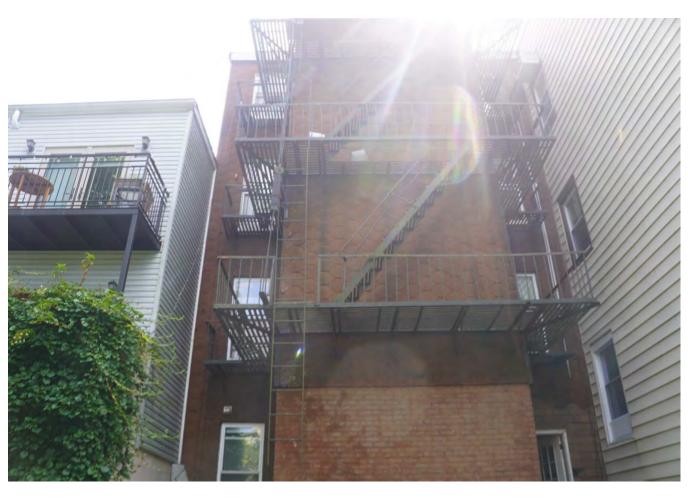
Rear exterior

Wear / aging noted at exterior walls. Regular service / maintenance is needed to prolong longevity. Rear siding at end of serviceable lifespan with heavy wear / aging - further evaluation for replacement is needed to prevent moisture penetration / damage.

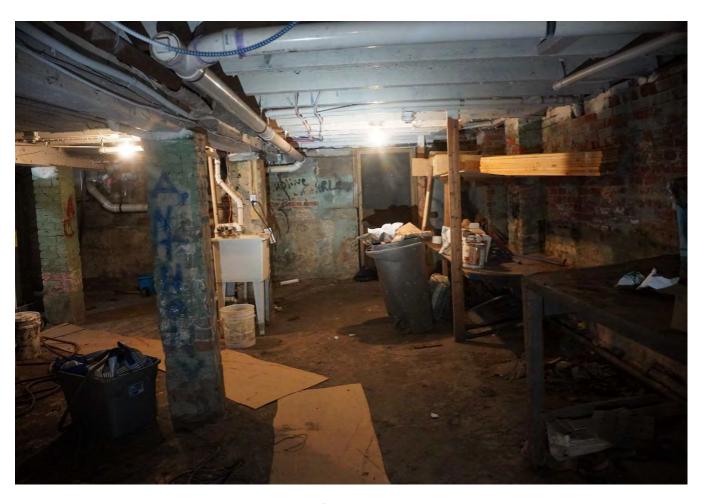
Basement

Gap noted at basement exterior walkout door - repair is needed. Moisture noted at basement interior. Microbial growth noted at basement interior - remediation is needed. Recommend installation of dehumidifier to reduce moisture levels. Further evaluation for waterproofing is needed. Construction debris noted in basement - removal is needed. Loose & worn bricks & deteriorated mortar noted at interior foundation walls - further evaluation & repair is needed by a masonry contractor to maintain structural integrity of the building.

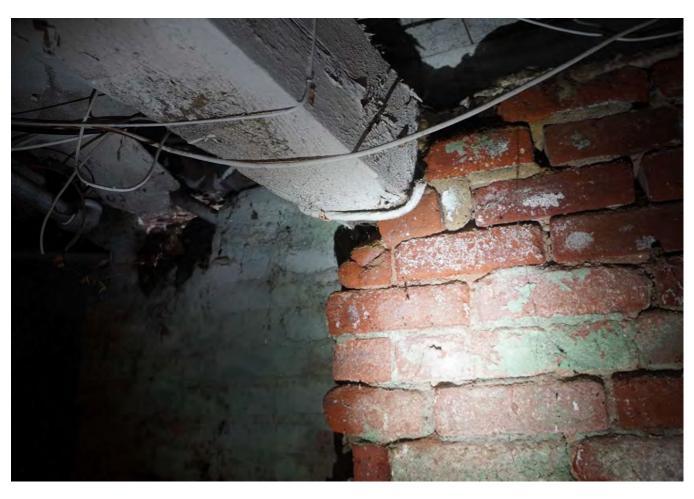
Twisting noted at main girder and joist - further evaluation for reinforcement is needed by a structural contractor to maintain structural integrity of the building.

Twisting at main girder

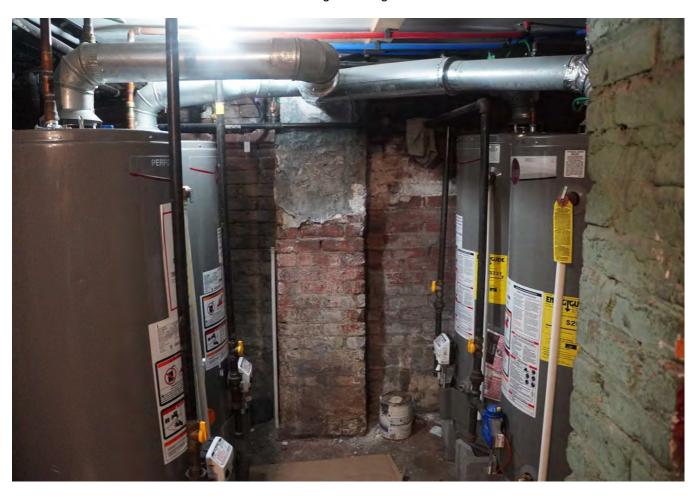
Hot water heaters recently replaced (2018, 2020, 2023), request warranty / permit information from seller.

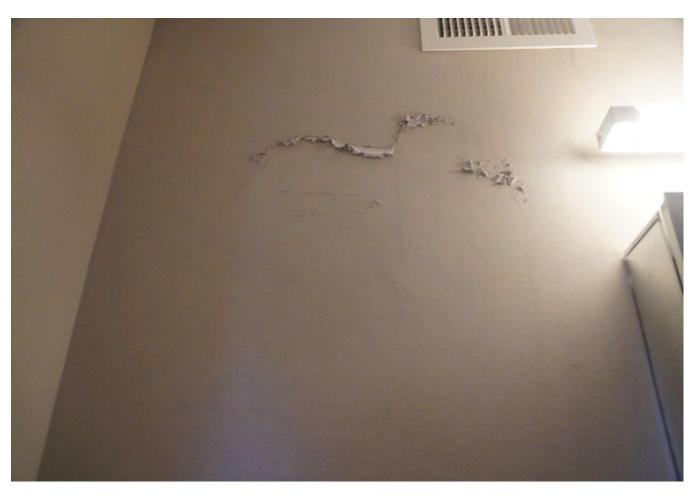
Peeling paint

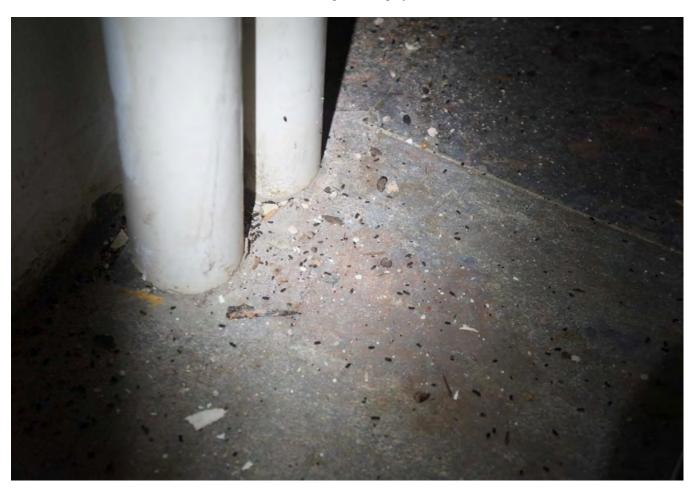
Rodent droppings

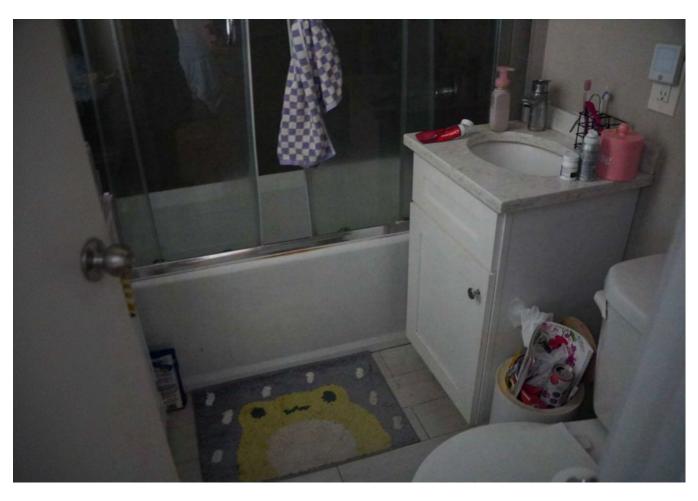
Unit 3 primary bathroom

Ventilation fan not operational at unit 3 primary bathroom - repair is needed.

Comment					
Ventilation fan not ope	erational at unit 3 primary	bathroom - repair is neede	ed.
